**SPECIAL ENGINEERING SERVICES TO
ESTABLISH INSPECTION CRITERIA FOR
BEARINGS TO IMPROVE LIFE PREDICTION**

FINAL ENGINEERING REPORT

SwRI Project 15-4012

Warner Robins Air Logistics Command
Directorate of Materiel Management
Robins Air Force Base, Georgia 31093

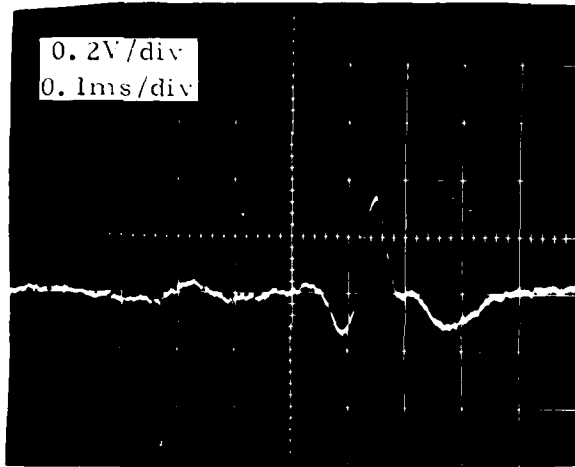
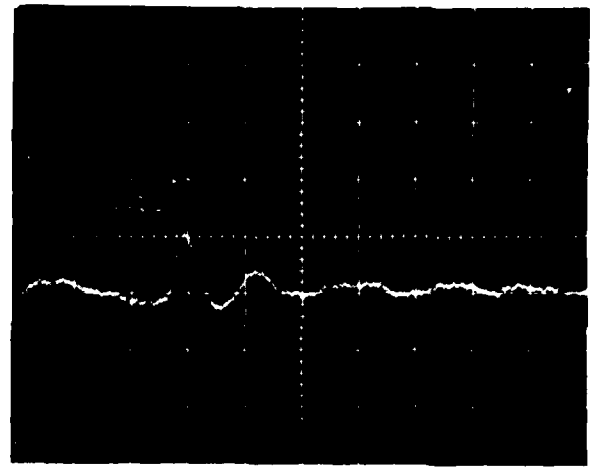
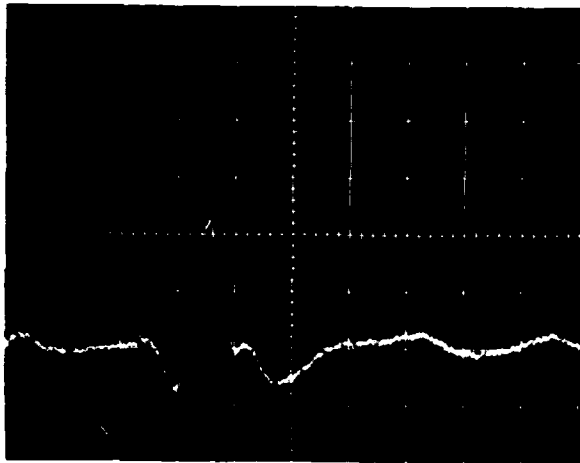
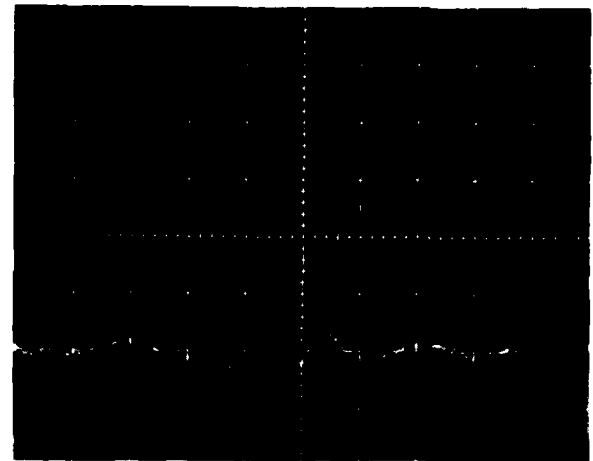
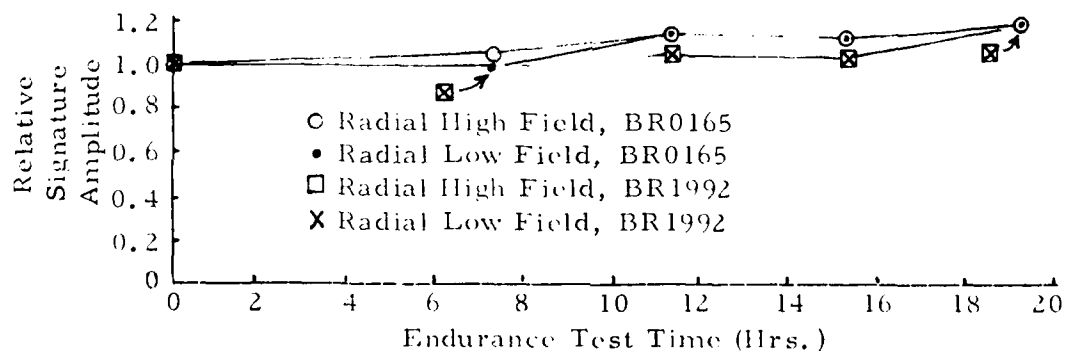
| Test Results | Prior Signature | Test Data Hrs - Stress | Bearing Type | Remarks | AF S/N (SwRI No.) | Test Ref. No. |
|---|---|---|---|---|---|---|
| Spall | CH, 0009-0165 | 26.2-332 ksi | J57-#4 | Inner race, NLH; 5678 hrs. service | 748A-1 (S10981) | 3 |

FIGURE F7. MAGNETIC PERTURBATION RADIAL FLUX SIGNATURES AT FLAW LOCATIONS 0009-0165 AND 0010-1992 AS A FUNCTION OF ENDURANCE TEST TIME, J57-#4 BEARING S/N 748A-1, INNER RACE S10981(1).

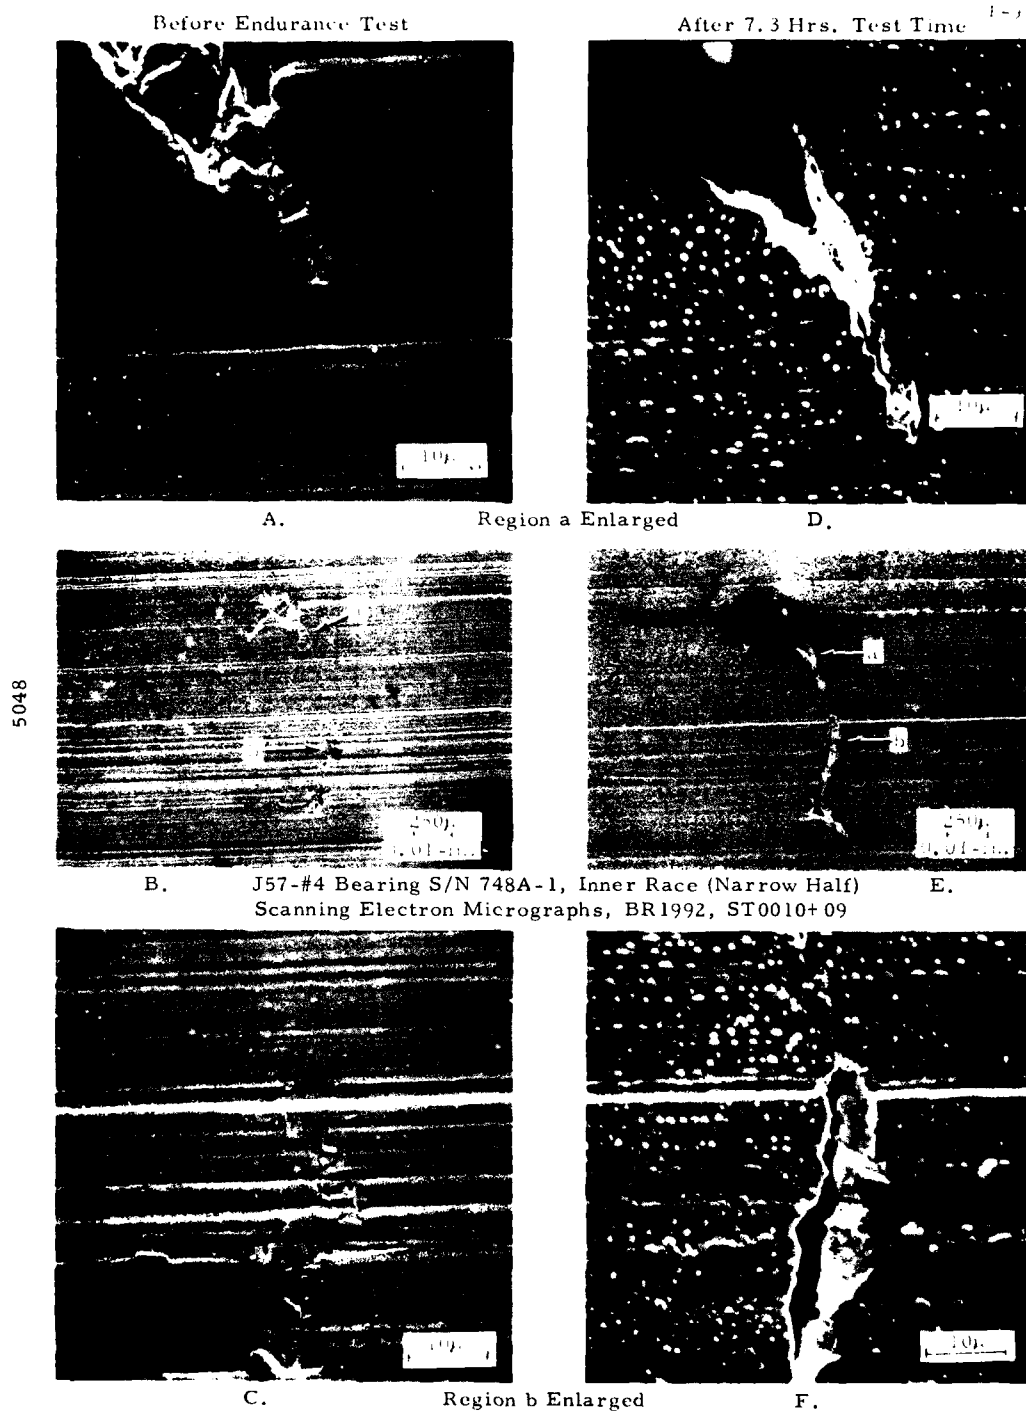
FIGURE P9. REPLICATION (SEM) RESULTS AT 0 HRS AND 7.3 HRS ENDURANCE TEST TIME IN VICINITY OF FLAW SIGNATURE AT 0010-1992, J57-#4 BEARING (S/N 748A-1) INNER RACE S10981(1) (5678 hrs., reworked).

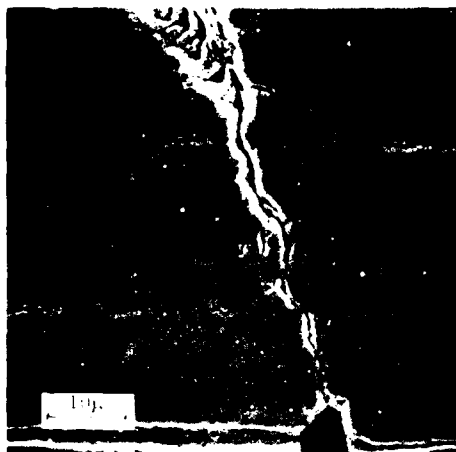
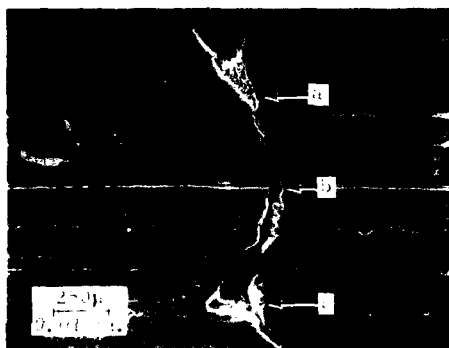
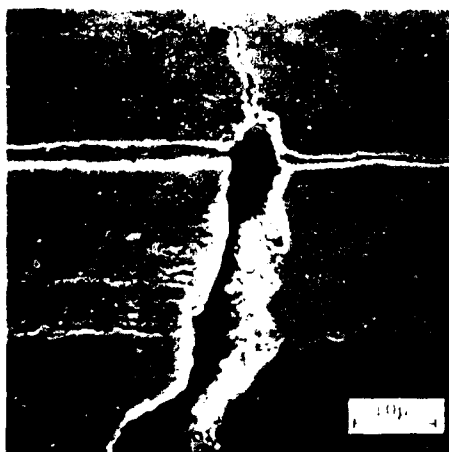
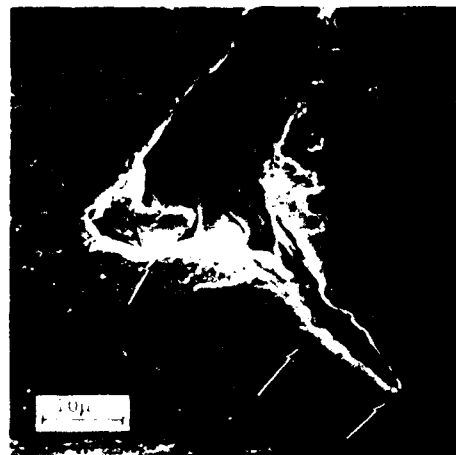
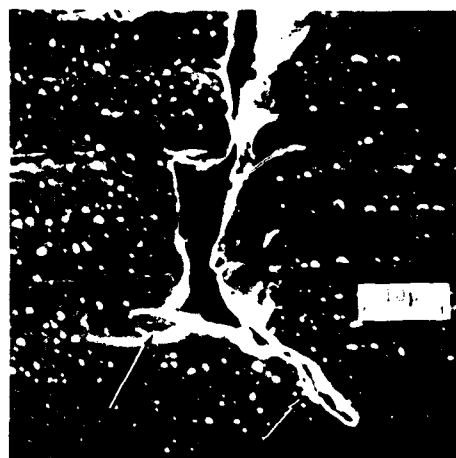
Arrows indicate regions of crack
progression and material loss.

FIGURE F10. REPLICATION (SEM) RESULTS AT 26.2 HRS ENDURANCE TEST
TIME IN VICINITY OF FLAW SIGNATURE AT 0010-1992, J57-#4
BEARING (S/N 748A-1 INNER RACE S10981(1) (5678 hrs., reworked)).

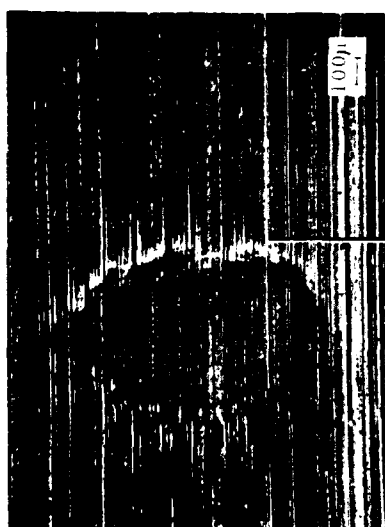
FIGURE F13. METALLURGICAL SECTIONING RESULTS SHOWING MATERIAL TRANSFORMATIONS IN VICINITY OF INDENTATION AT 0023-4462, J57-#4 BEARING S/N 748A-1 OUTER RACE S10981(5) (26.2 hrs. endurance test time).

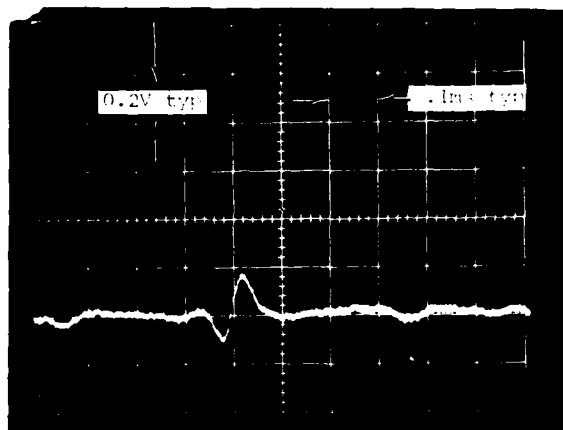
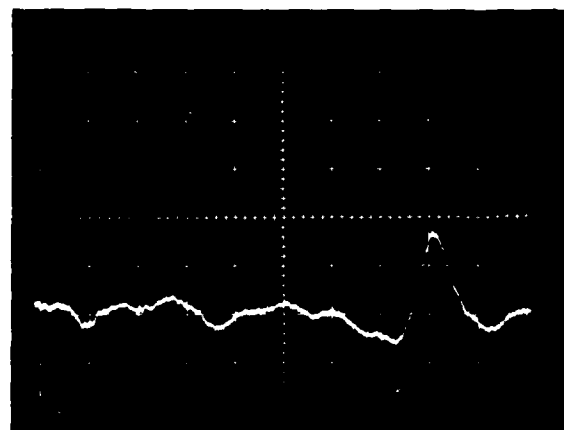
Magnetic Perturbation Signatures After Endurance Test (3.7 hrs., 332 ksi)

C. Magnified View (50x) of Surface After Endurance Test

FIGURE F14. CIBLE INSPECTION RESULTS ON J57-#4 BEARING (S/N 1325-2) INNER RACE, LOADED HALF, VENDOR REWORKED, 6769 HRS SERVICE AFTER ENDURANCE TEST (S10782-3).

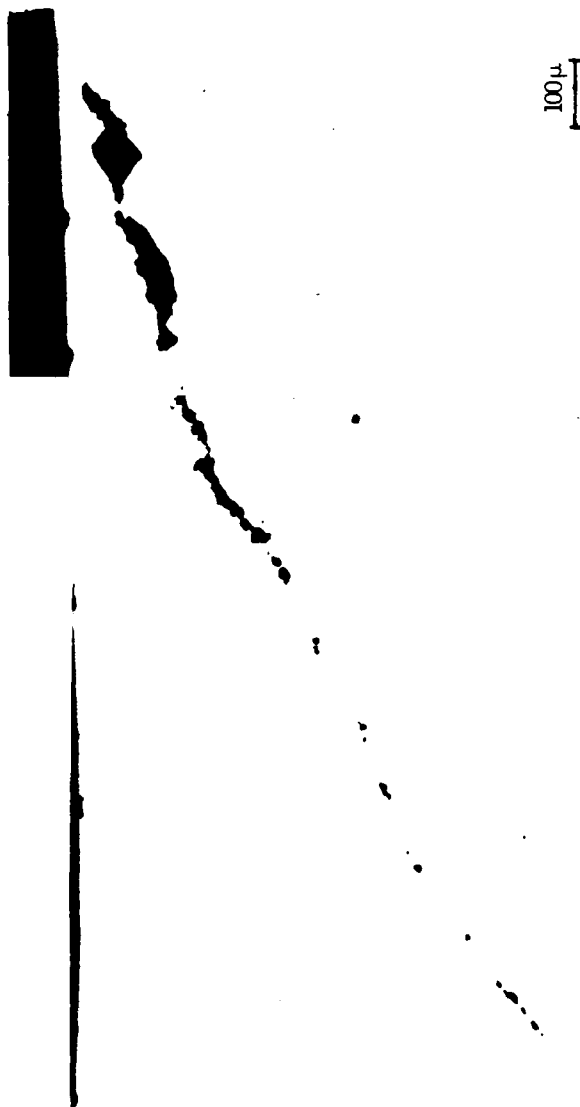
FIGURE F15. J57-#4 BEARING, INNER RACE, LOADED HALF
S/N 1325-2 (S10782-3) BR 4390, ST13

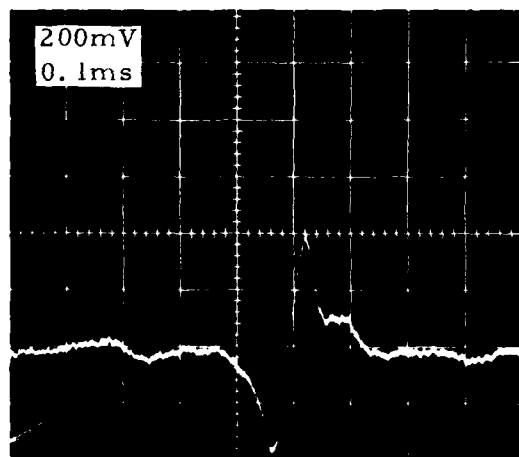
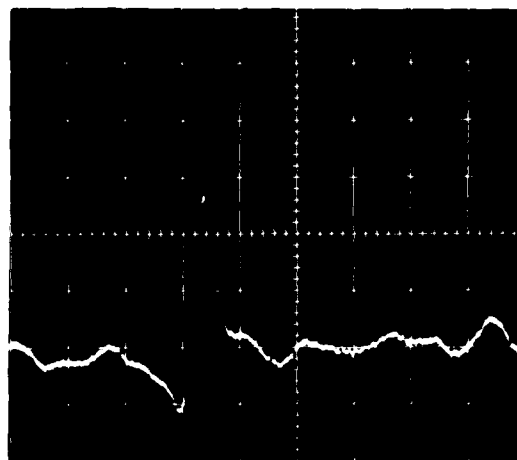
FIGURE F17. CIBLE RESULTS ON J57-#2 BEARING (S/N 1440-2) INNER RACE, LOADED HALF [S00762(3)] (6965 hrs. service - Vendor reworked bearing, accepted by Air Force as serviceable).

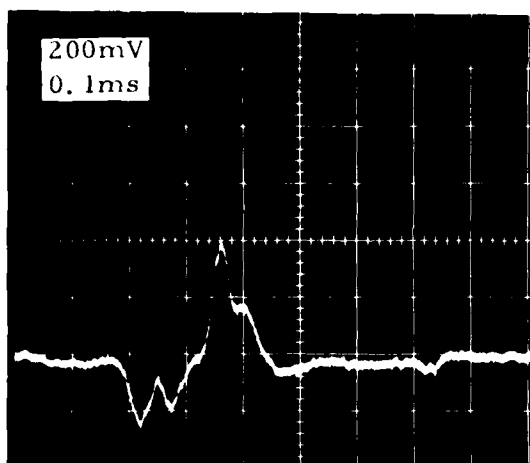
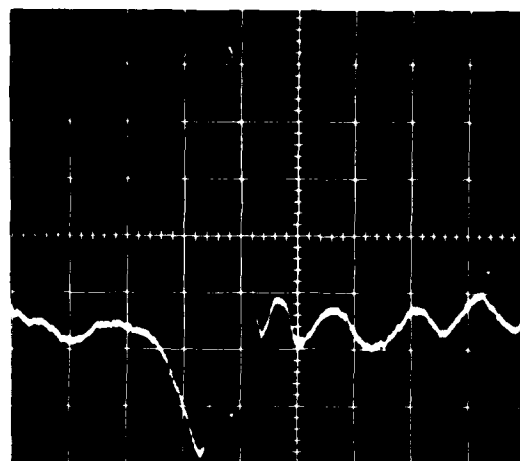
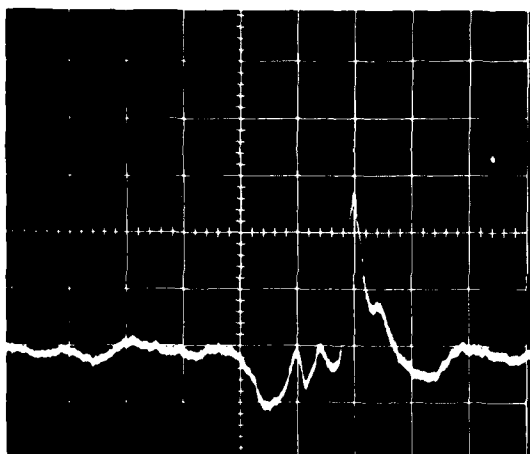
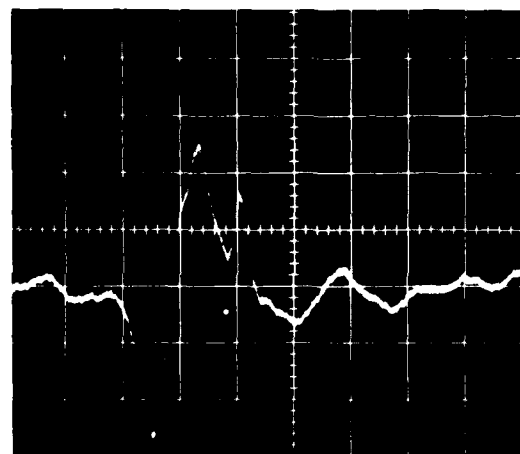
FIGURE F18. CIBLE RESULTS ON J57-#2 BEARING (S/N 1440-2) INNER RACE, LOADED HALF [S00762(3)] (6965 hrs. service - Vendor reworked bearing, accepted by Air Force as serviceable).

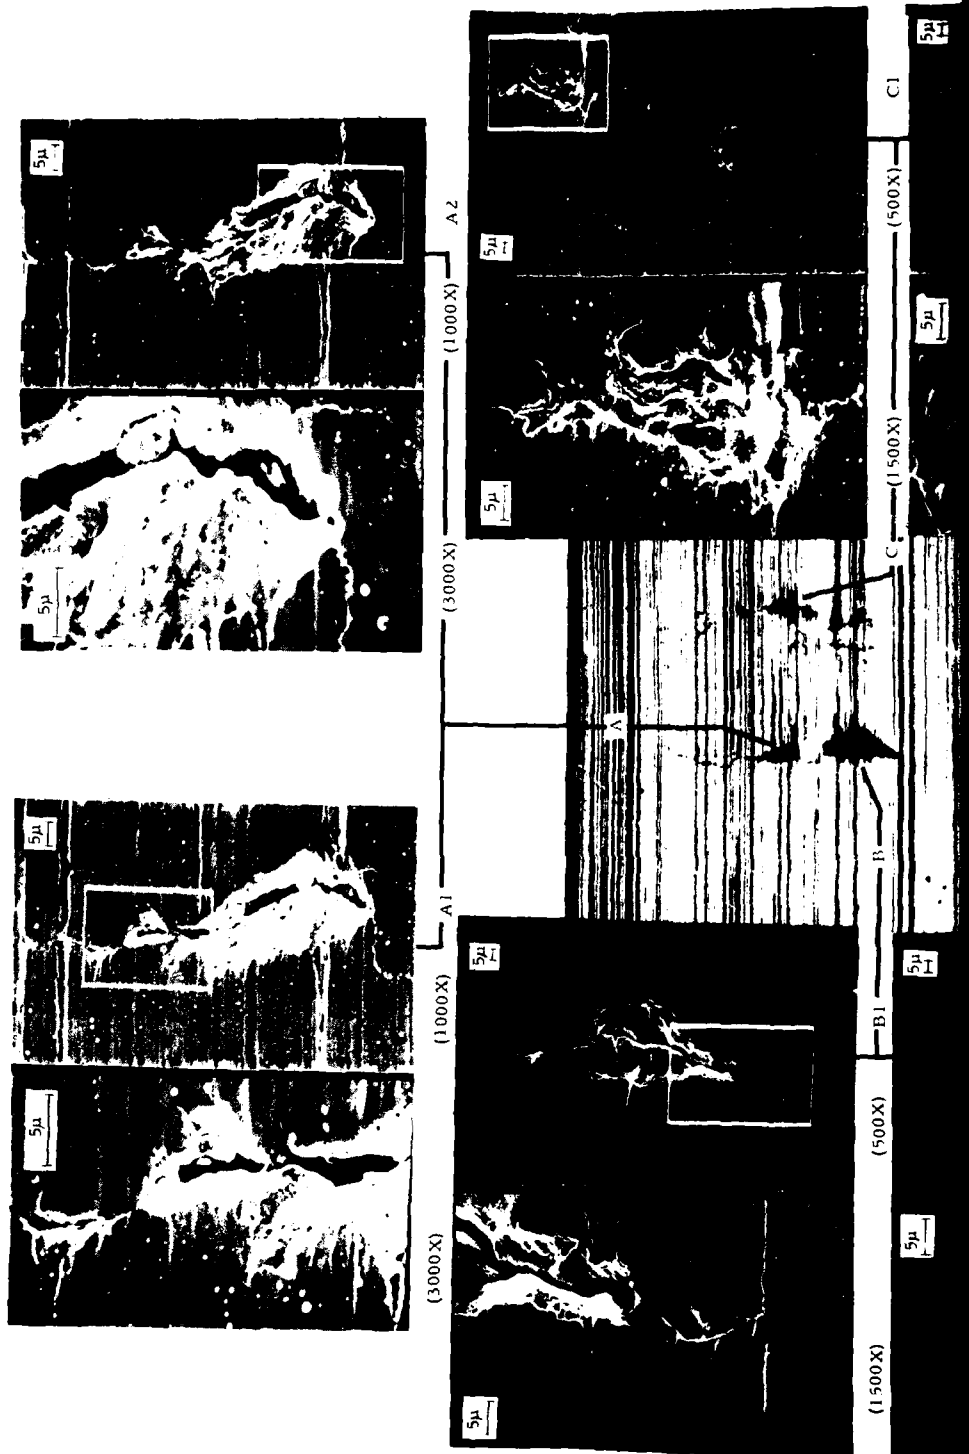
FIGURE F19. REPLICATION
(0002/0008-2)
(S00762) (69)

LOCATION RESULTS FROM LARGE CRACK NETWORK IN VENDOR REWORKED BEARING
 1/0008-2290, J57-#2 Bearing S/N 124 - Inner Race, Loaded Half
 (62) (6965 hrs. service).

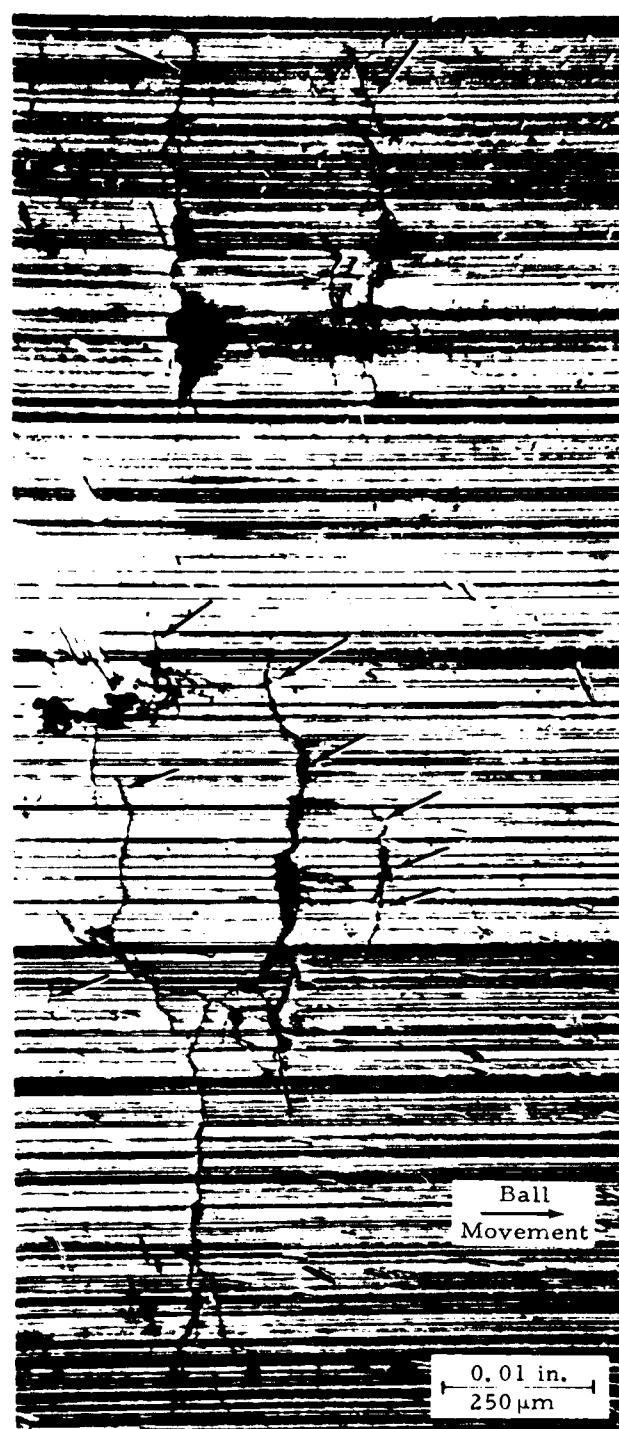
Small arrows point out regions of crack propagation.

FIGURE F20. SURFACE PHOTOMICROGRAPHS SHOWING CRACK NETWORK "BEFORE" AND "AFTER" 1 HR ENDURANCE TEST [S00762(3)].

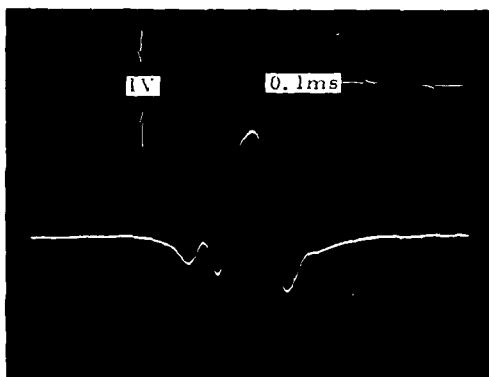
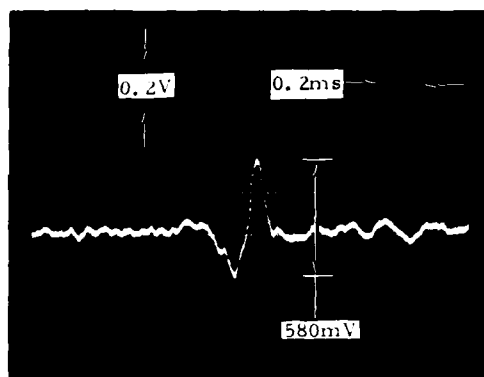
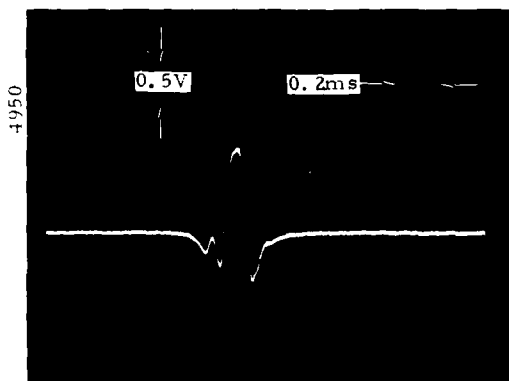
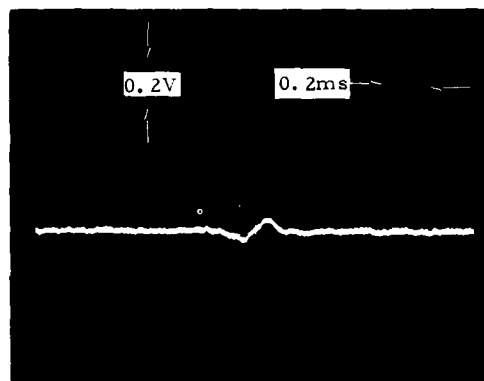
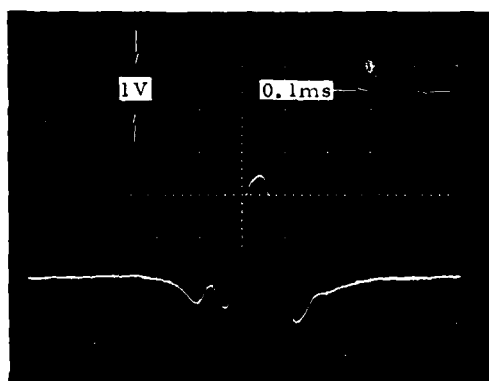
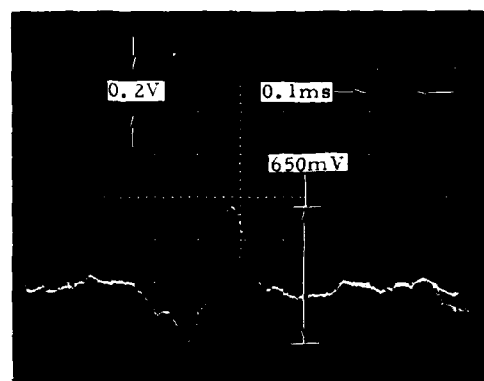
| Test Results | Prior Signature | Test Data Hrs - Stress | Bearing Type | Remarks | AF S/N (SwRI No.) | Test Ref. No. |
|---|---|---|---|--|---|---|
| Pit Deterioration | | 12.0-332 ksi | J85-#2 | Inner race, NLS; 1133 hrs. service | A4230 (S30211) | 4 |

FIGURE F21. MAGNETIC PERTURBATION SIGNATURES AT TWO ENDURANCE TEST INTERVALS FROM LARGE SURFACE FLAW AT 0006+18 IN J85-#2 BEARING S/N A4230, INNER RACE, NONLOADED HALF (1133 hrs. service time) (S30211).

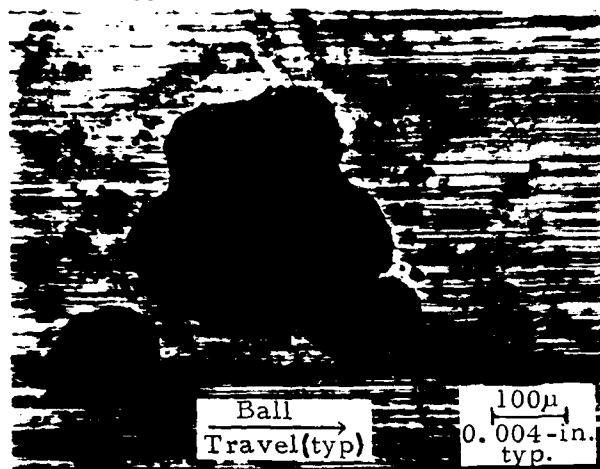
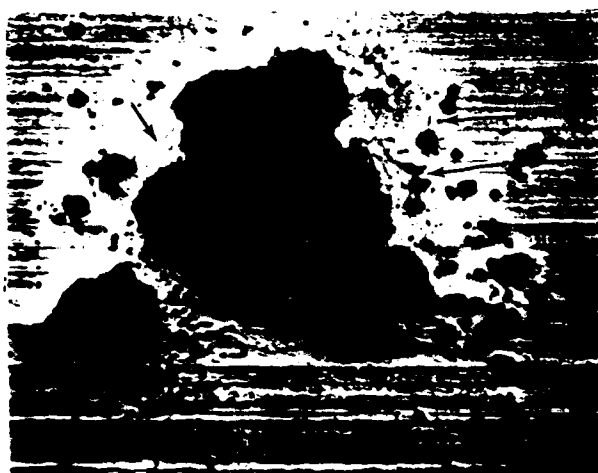
Surface Flaw @ 0006+18-3547

Surface Flaw @ 0007+4-3679

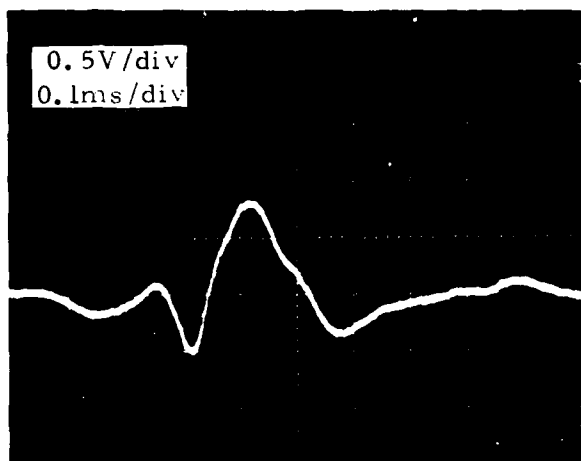
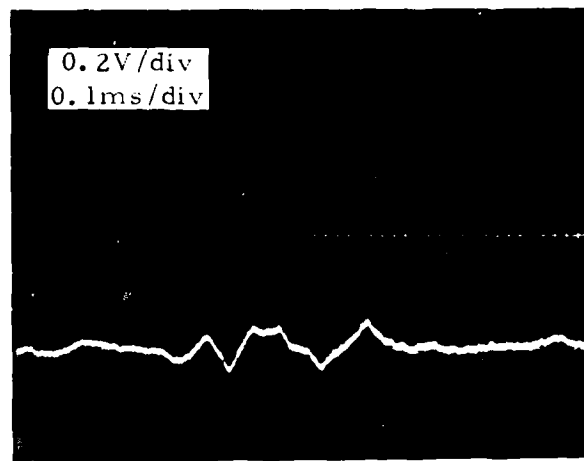
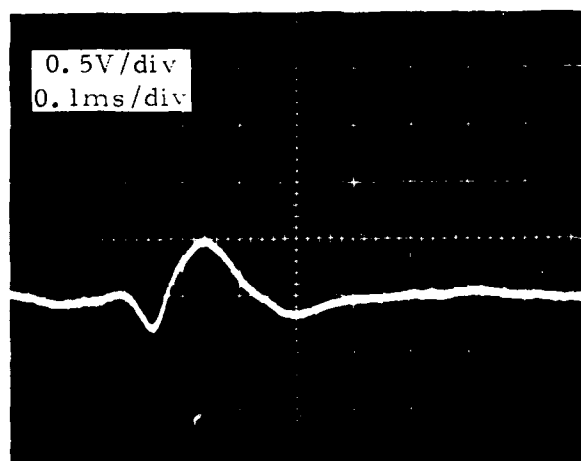
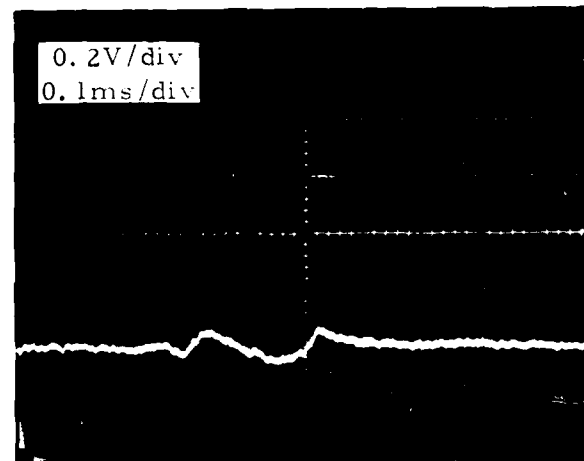
(BR 1288, ST0013+06)

FIGURE F23. MAGNETIC PERTURBATION SIGNATURES FROM SERVICE INDUCED CRACK NETWORK AT0013-1288 IN J57-#4 BEARING S/N 6857-1, INNER RACE LOADED HALF S11281(3) (1668 hrs. service, Vendor reworked).

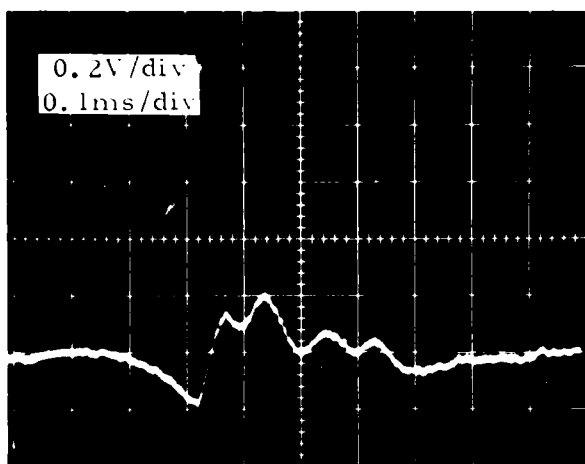
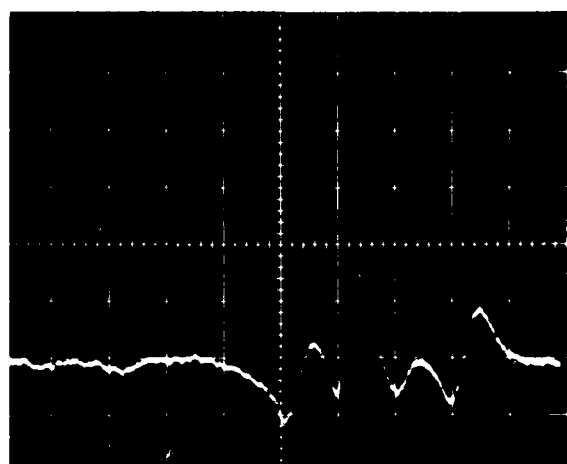
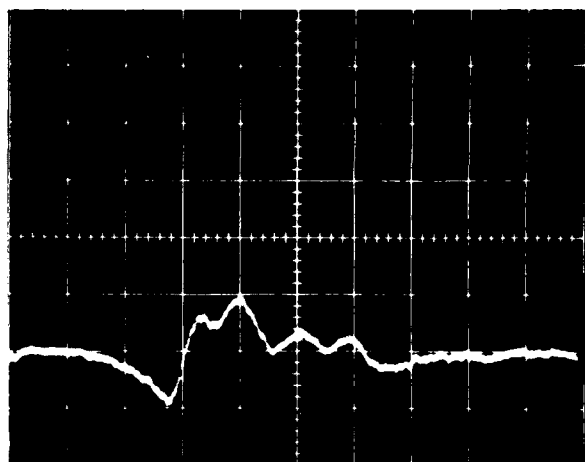
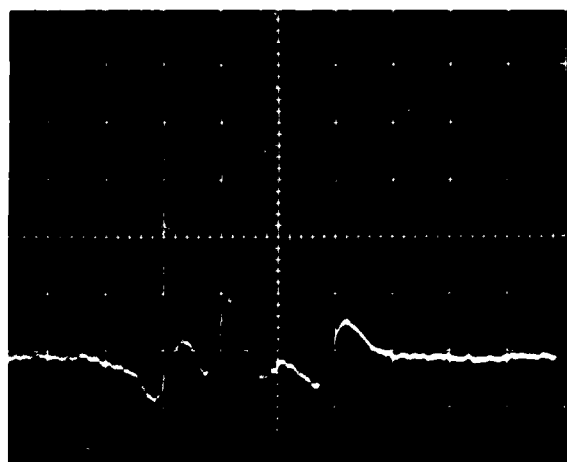
(BR 2127, ST0007+08)

FIGURE F25. MAGNETIC PERTURBATION SIGNATURES FROM SERVICE INDUCED CRACK NETWORK AT 0007, 0008-2127 IN J57-#2 BEARING S/N 2916-2, OUTER RACE S00722(5) (7259 hrs. service, vendor reworked).

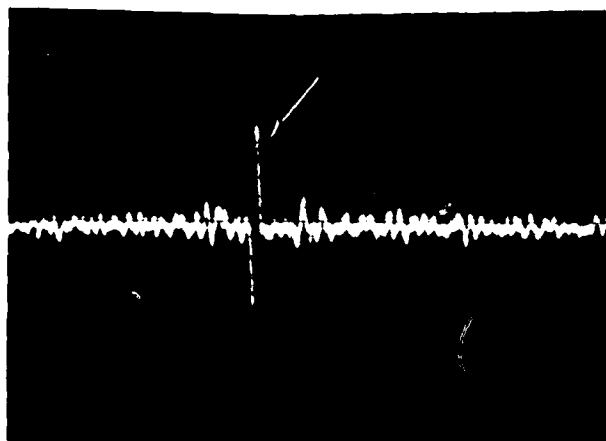
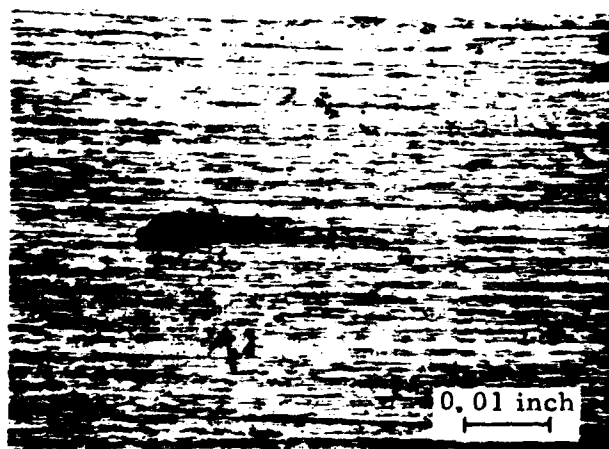
RH Signature @ 0005-4405

Magnified (50X) View of Surface @ 0005-4405

FIGURE F28. CIBLE RESULTS ON J57-#2 BEARING (S/N 704A-1) INNER RACE (New Bearing).

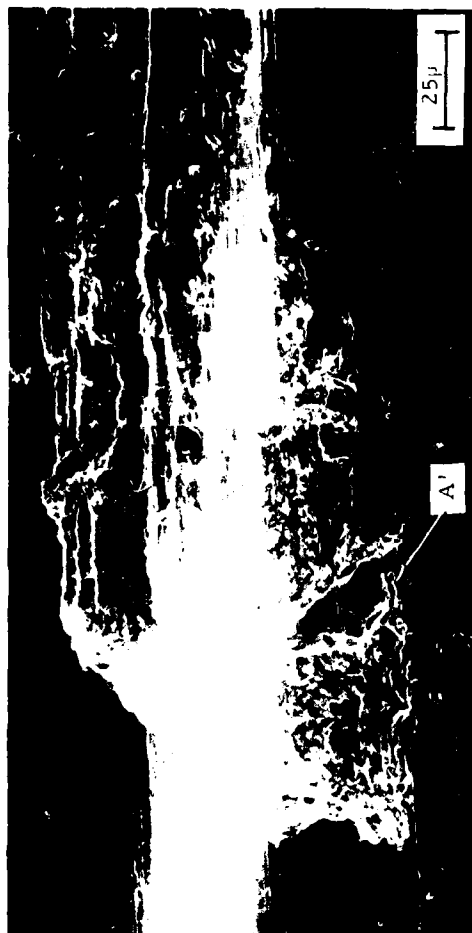
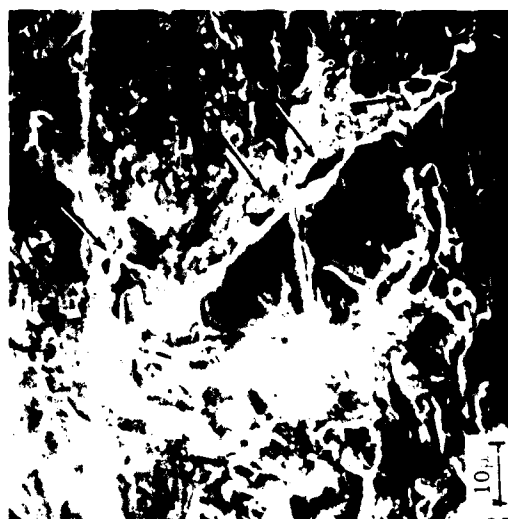
FIGURE F29. SCANNING ELECTRON MICROSCOPE (SEM) PHOTOGRAPHS OF SURFACE
IMPERFECTION (Replica) AT 0005-4405, J57-#2 BEARING (S/N704A-1)
INNER RACE (New Bearing).

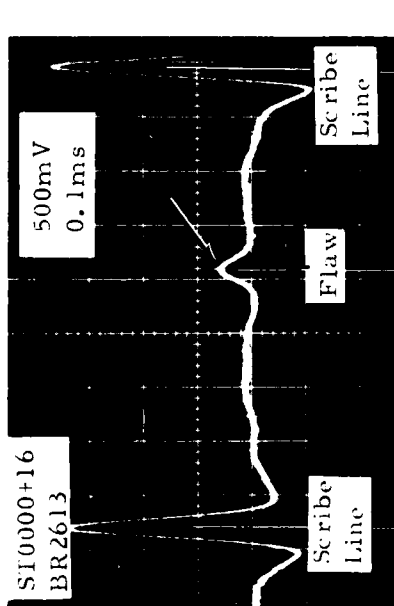
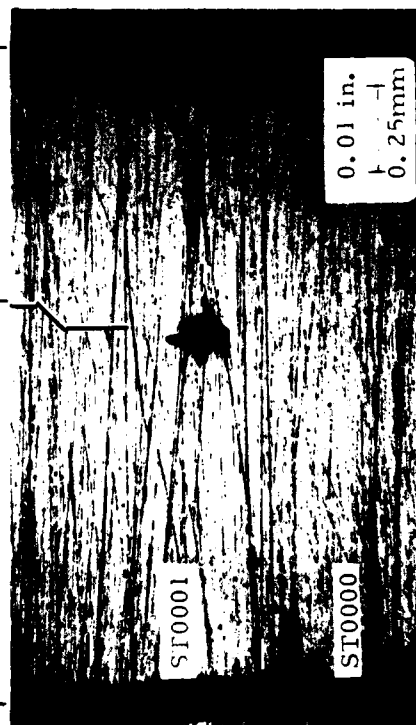
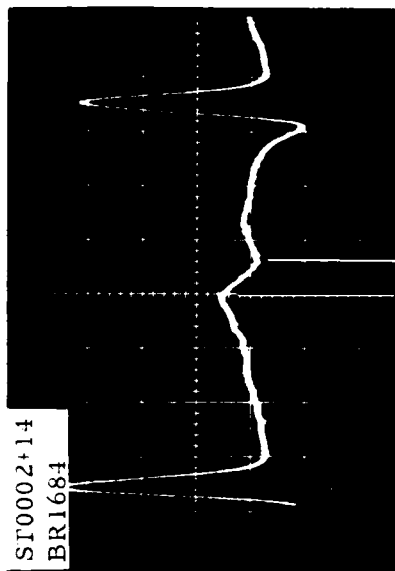
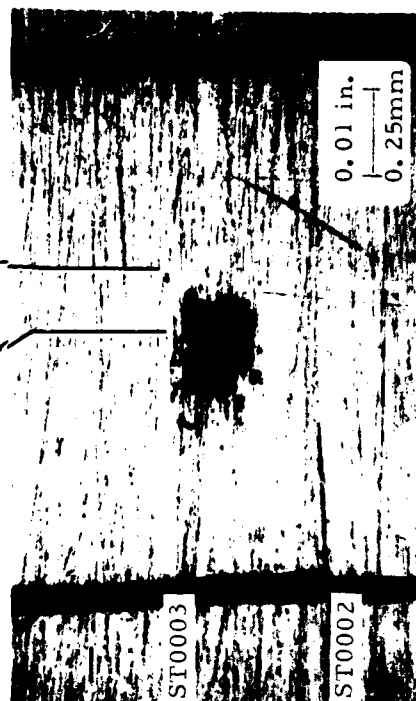
FIGURE F30. MAGNETIC PERTURBATION RADIAL SIGNATURE RECORDS AND SURFACE PHOTOMICROGRAPHS ILLUSTRATING METHOD FOR ACCURATELY DETERMINING FLAW SIGNATURE LOCATIONS ON J57-#4 BEARING (S/N 141C-1) INNER RACE S10071(2) (reparable bearing, 7946 hrs. service).

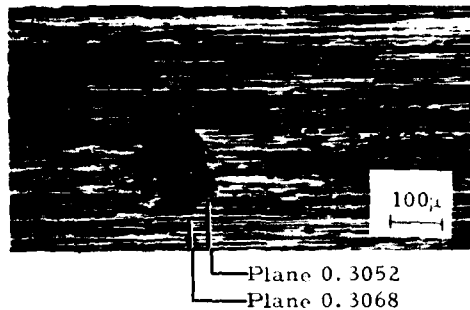
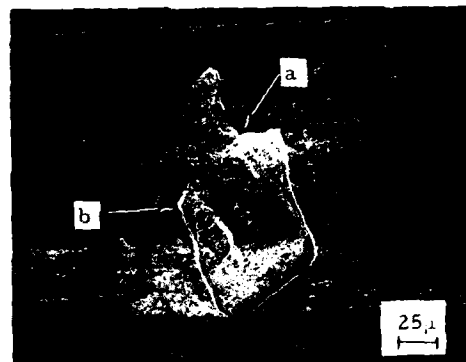
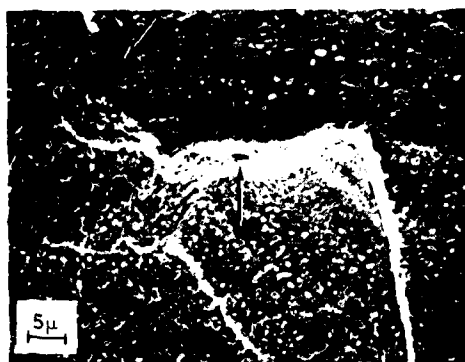
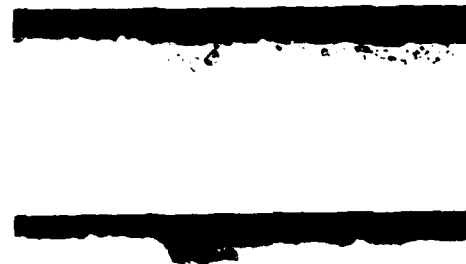
FIGURE F31. REPLICATION AND METALLURGICAL SECTIONING RESULTS FOR
SURFACE IMPERFECTION AT 0001-2613, J57-#4 BEARING INNER
RACE S/N 141C-1 REPARABLE REJECT S10071(2).

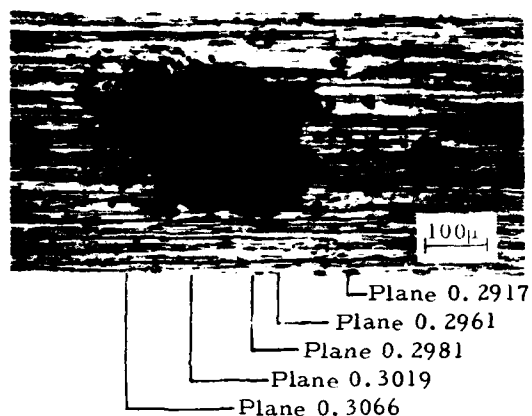
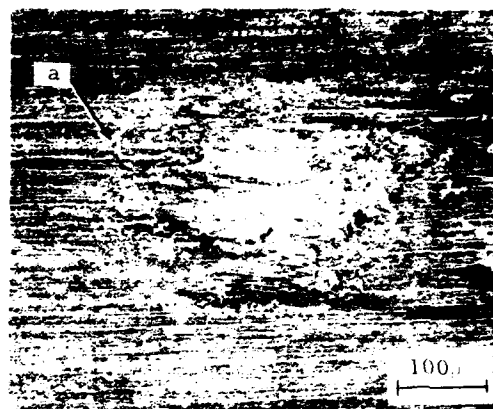
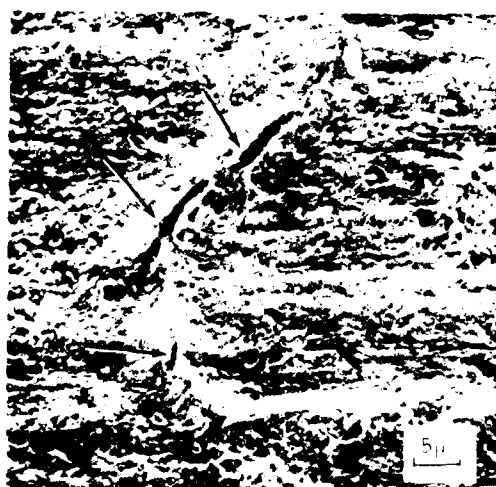
FIGURE F32. REPLICATION AND SECTIONING RESULTS FOR SURFACE IMPERFECTION
AT 0003-1684, J57-#4 BEARING (S/N 141C-1) INNER RACE S10071(2)
(Reparable Reject, 7946 Hrs.)

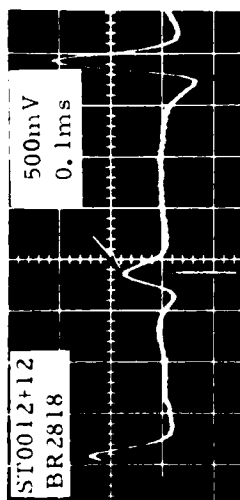
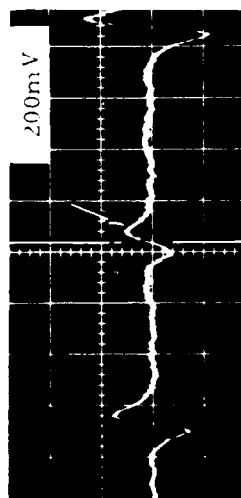
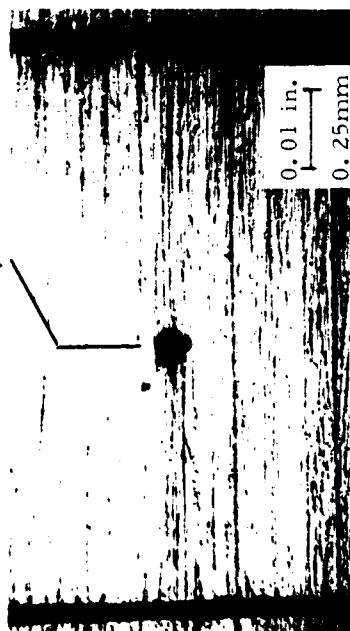
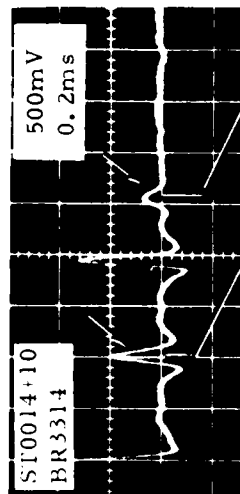
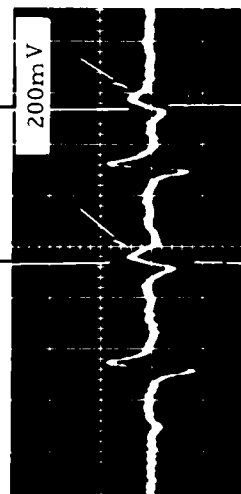
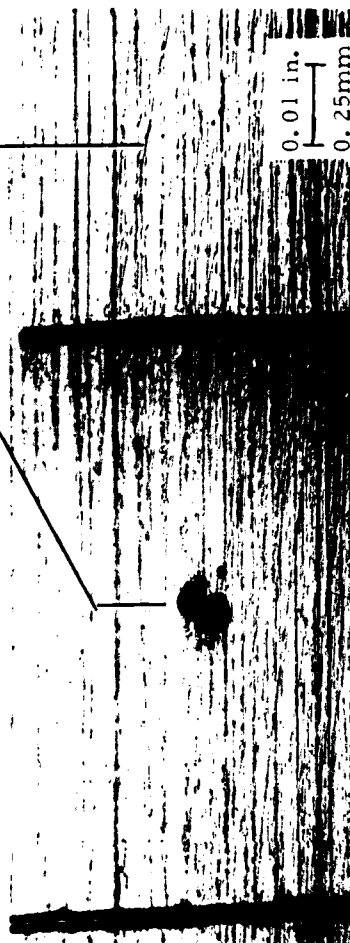
FIGURE F34. MAGNETIC PERTURBATION RECORDS AND SURFACE PHOTOMICROGRAPHS ILLUSTRATING
CORRESPONDING LOCATIONS OF SIGNATURES ON J57-#4 BEARING (S/N 427C-1) INNER
RACE S10141(3) (reparable bearing, 8337 hrs. service after rework).

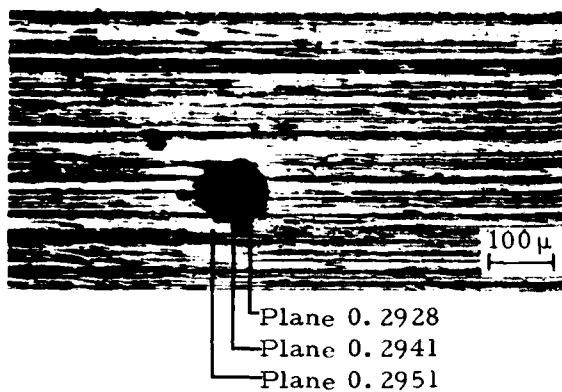
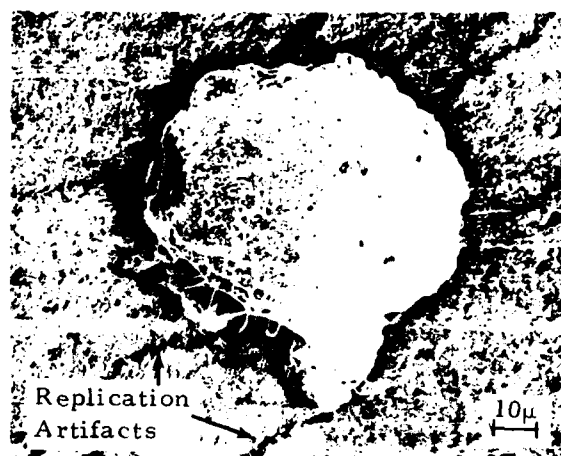
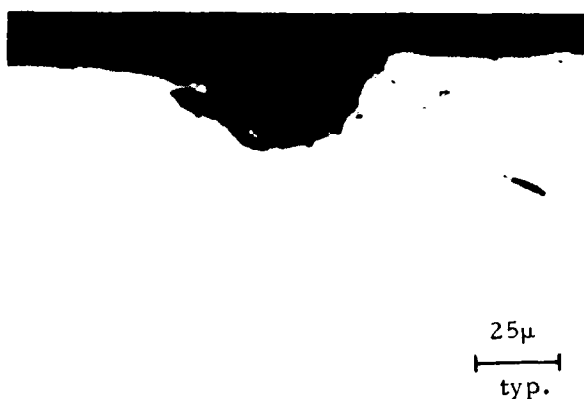
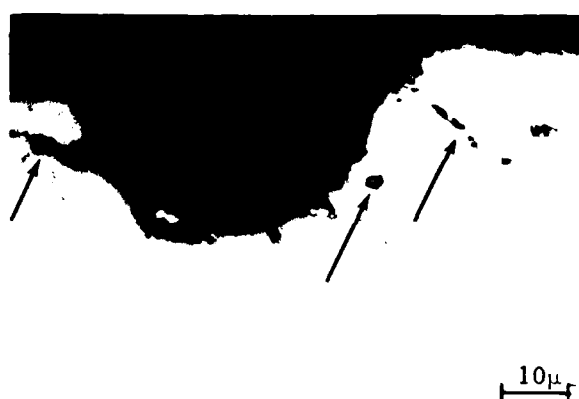
FIGURE F37. REPLICATION AND SECTIONING RESULTS FOR SURFACE INCLUSION PIT AT 0014-3314, J57-#4 BEARING (S/N 427C-1) INNER RACE S10141(3) (8337 hrs. after rework, repairable).

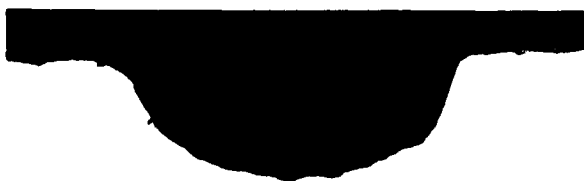
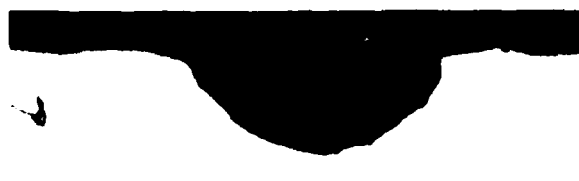
E. Section Plane 0.2941 500X

FIGURE F35. REPLICATION AND METALLURGICAL SECTIONING RESULTS FOR
SURFACE INCLUSION PIT AT 0013-2818, J57-#4 BEARING
(S/N 427C-1) INNER RACE S1014(3) (8337 hrs. after rework,
reparable).

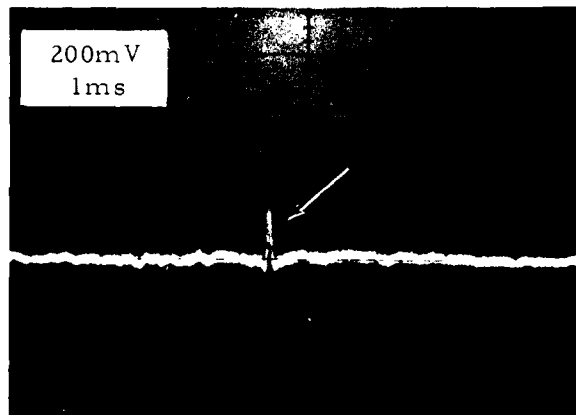
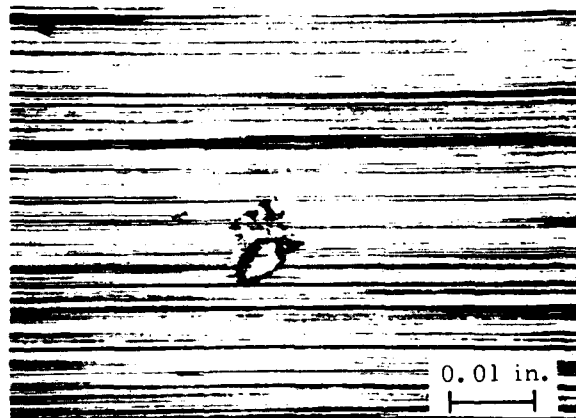
RH Signature @ 0011-2469

FIGURE F38. CIBLE RESULTS ON J57-#4 BEARING (S/N 7563-2) OUTER RACE S10992(5) (reworked bearing with 700 hrs. service - service prior to rework unknown).

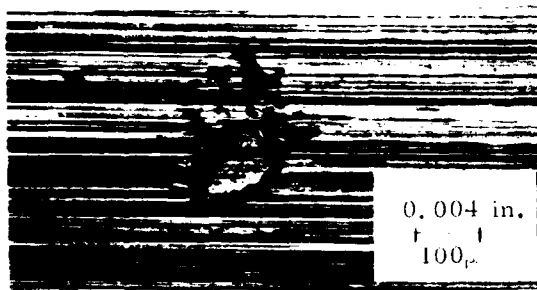
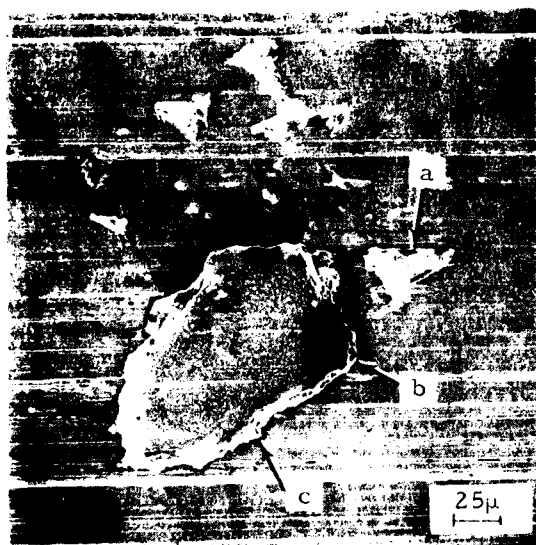
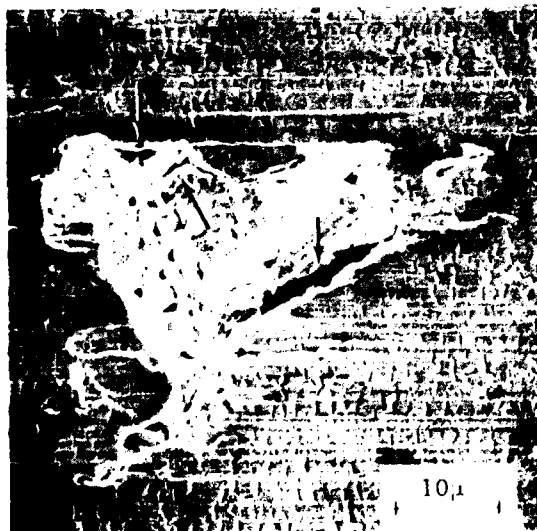
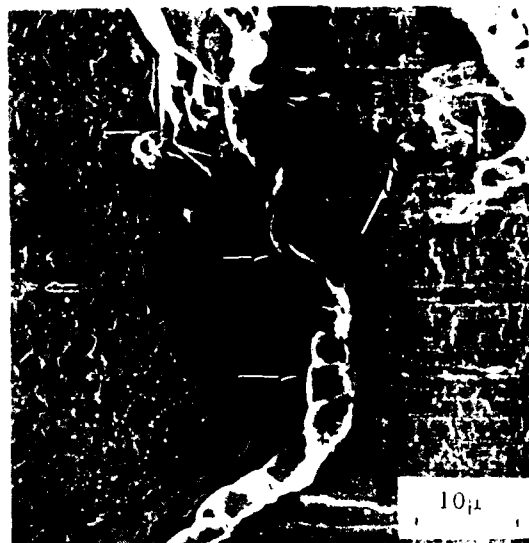
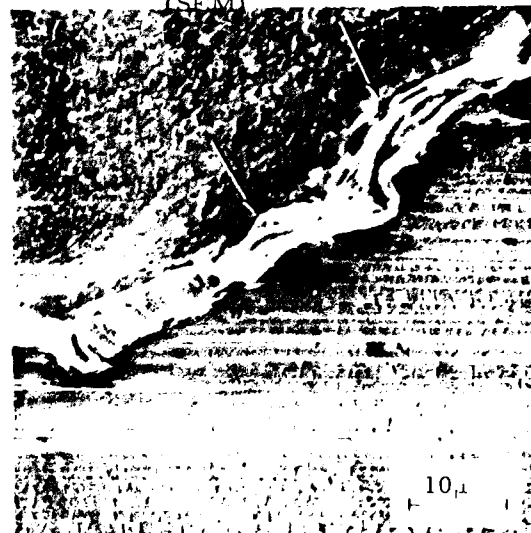
A. Optical Photomicrograph ($\sim 100X$)

FIGURE F39. OPTICAL AND SEM PHOTOMICROGRAPHS OF SURFACE IMPERFECTION AT 0011-2469, J57-#4 BEARING (S/N 7563-2) OUTER RACE S10992(5) (Reworked + 700 hrs.).

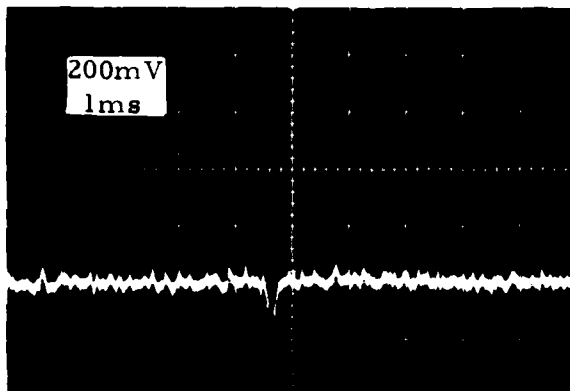
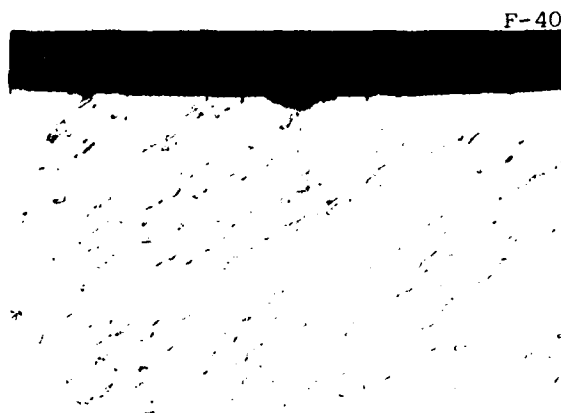
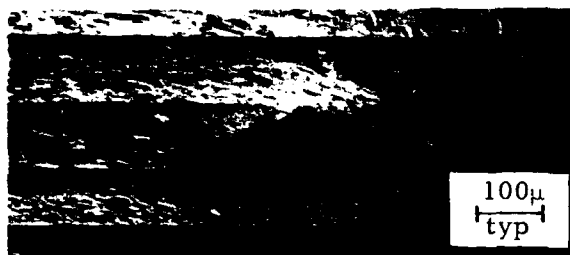
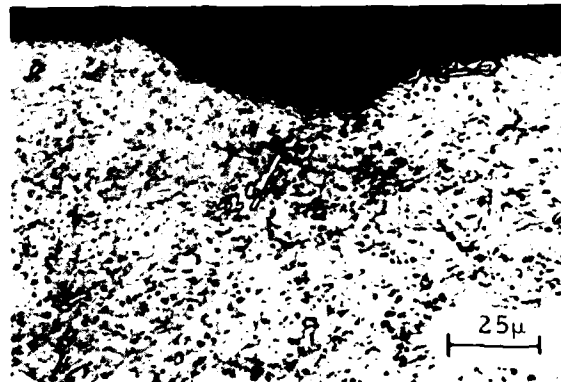
A. Radial Flux, High Field
Signature (© ST0006+16, BR4968)

FIGURE F40. METALLURGICAL SECTIONING RESULTS FOR SURFACE IMPERFECTION
AT 0006-4968, J85-#2 BEARING (S/N 06498) INNER RACE
S31091(2) (time limited, 2851 hrs.).

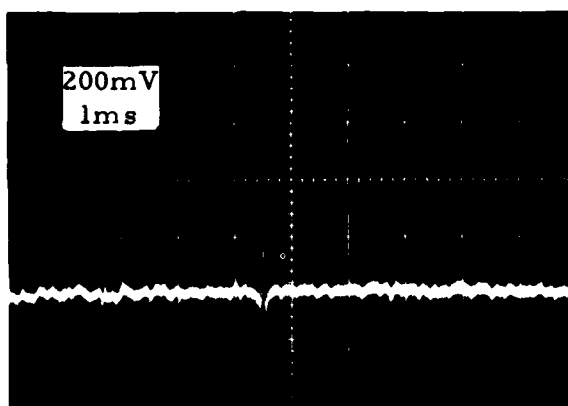
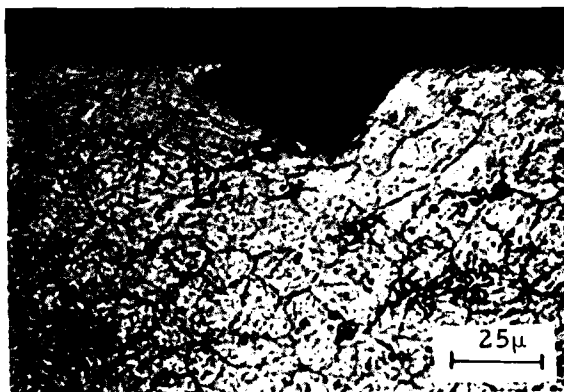
A. Radial Flux, High Field
Signature @ ST0005+ 10, BR0763

FIGURE F41. METALLURGICAL SECTIONING RESULTS FOR SURFACE IMPERFECTION
AT 0005-0763, J85-#2 BEARING (S/N 0743A) INNER RACE S31391(2)
(time limited, 1986 hrs.).
